Morea, J.P. & Garcia, M.C. (2016) - Geohistorical analysis of uses and activities on the waterfront of the “Parque Atlántico Mar Chiquito” Reserve, Argentina. *Journal of Integrated Coastal Zone Management / Revista de Gestão Costeira Integrada*, 16(1):95-104. DOI: 10.5894/rgci646 Supporting Information

## Supporting Information I

### Coastal Regression in Mar Chiquita

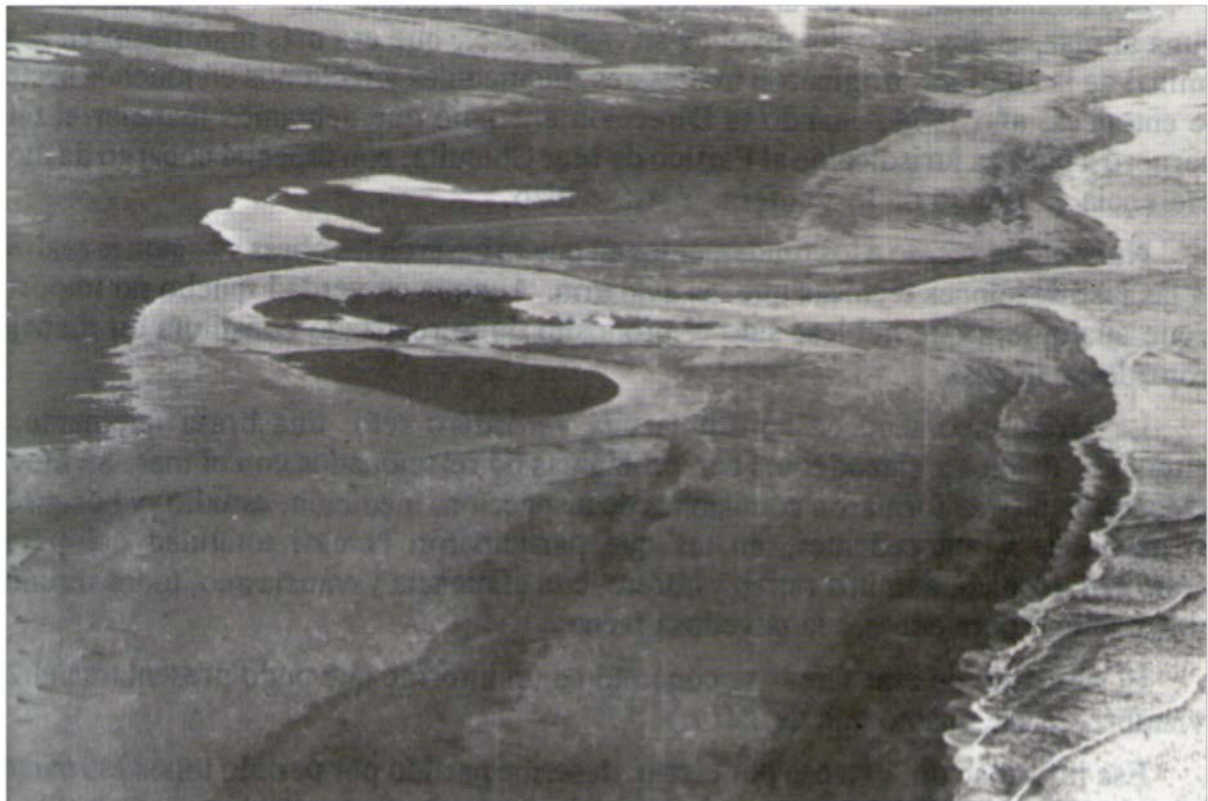
Figure SI-II-1 – Photography of the lagoon mouth in 1931. Source: Lagrange, 1993.

The following picture shows the conformation of the lagoon mouth in 1931. It is visible how the channel trend to go to north. Its current configuration goes to the south. Due to the lagoon mouth natural instability and severe erosion problems a series of coastal protections were performed by the public sector. The first intervention was in 1973 when a breakwater was built in the southern sector of the mouth of the lagoon which allowed its current configuration.

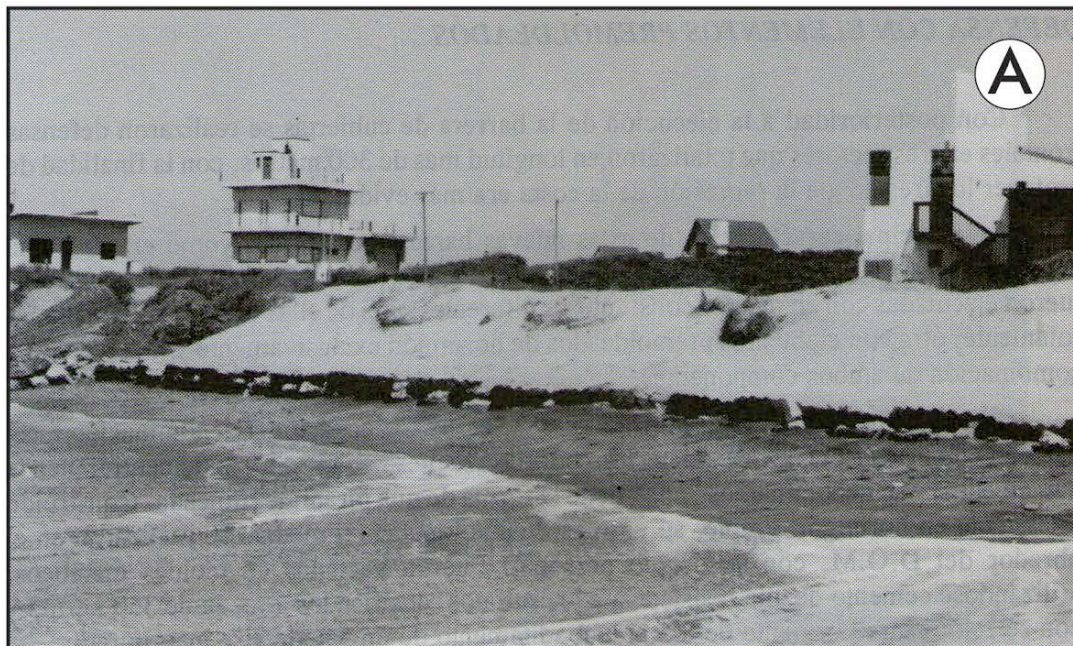
Figure SI-III - First coastal works at the lagoon mouth. Source: Lagrange, 1993

First coastal works at the Lagoon mouth were built in 1973, when a breakwater was built in the southern sector. A second phase started in 1982, coinciding with the town development and a better positioning as a tourist destination. This allowed an increase in the waterfront uses and a more active intervention of the public sector. According to Lagrange (1993), these early works were performed as an emergency. Therefore, in 1985 was performed a project that included the extension of the breakwater along with the construction, in a second stage, of two more breakwaters. The project came close to fruition, but eventually none of the actions planned were implemented. Over the years different techniques were applied. Firstly, pneumatics were located in line to protect the coastline, as seen in figure SI-IIIa), and then other concrete elements were used as shown in figure SI-IIIb).

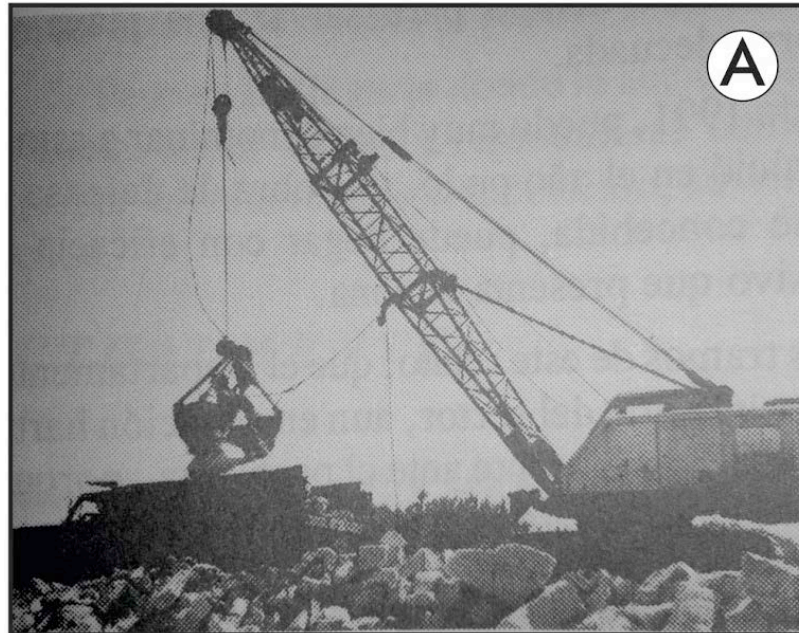
Figure SI-IVa - Constructions of the breakwater in 1991. Souce: Langrange, 1993

Figure SI-IVa shows the constructions of the breakwater in 1991.
