Lima & Amaral (2015) - Use of geoindicators in vulnerability mapping for the coastal erosion of a sandy beach. *Journal of Integrated Coastal Zone Management / Revista de Gestão Costeira Integrada*, 15(4):545-557. DOI: 10.5894/rgci502 [Supporting Information]

SI.1 - Photographs emphasizing aspects of the study area. Their positions are indicated in Figure 1 of the article.

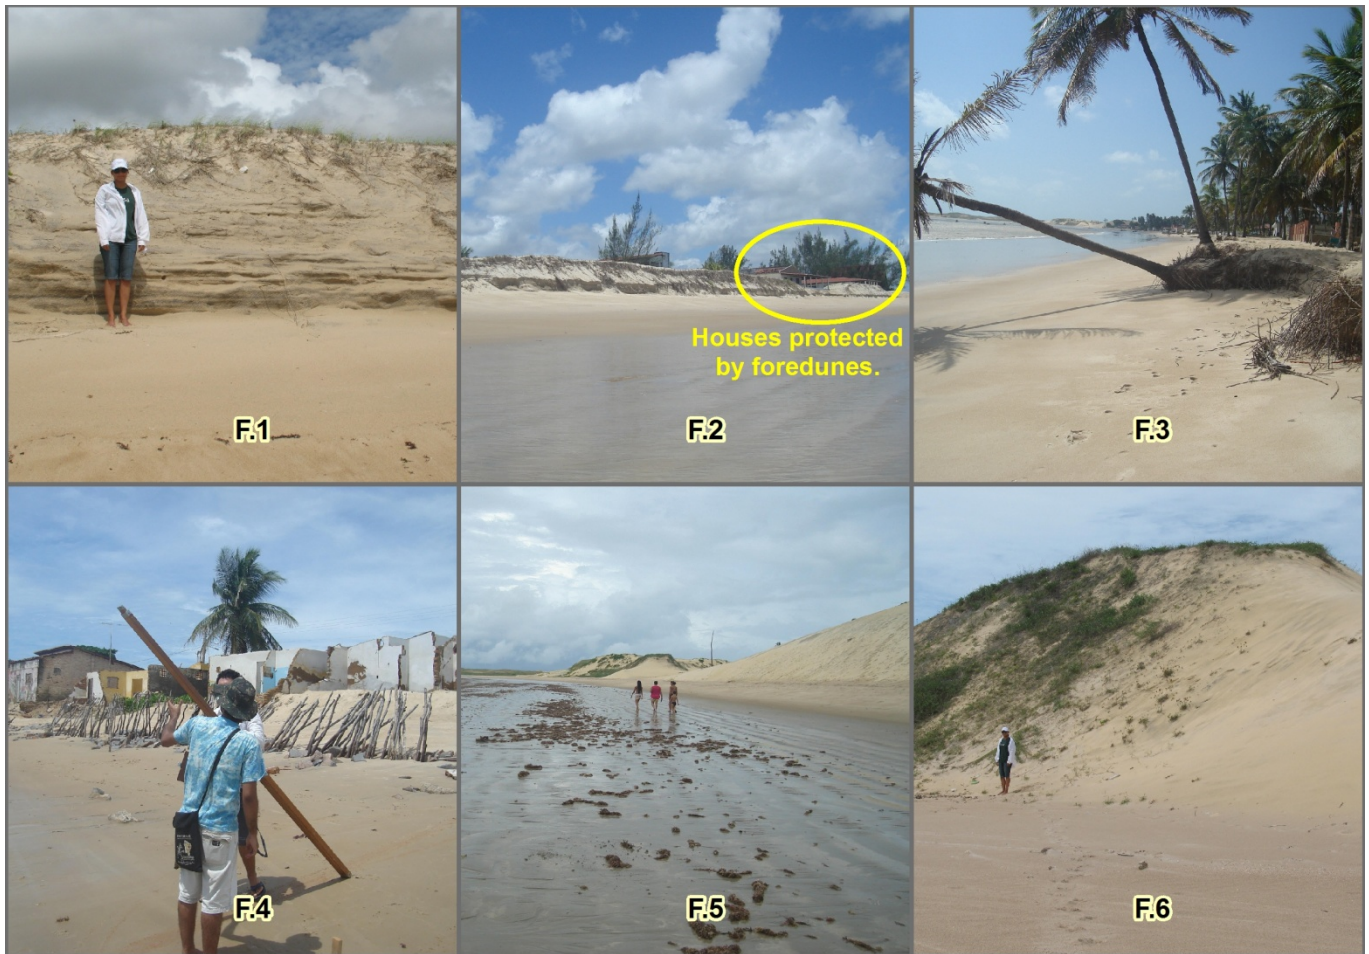
F.1 – Escarped foredunes. F.2 – Fore dune protecting homes from the beach erosion. F.3 – Coconut trees with exposed roots revealing the existing erosion process. F.4 – Zone most affected by erosion. Use of fences and stones to contain the sea's action. F.5 – Transgressive dunes. Figure F.6 – Field of dunes that have migrated from Maracajaú beach and have reached Pititinga beach (most southerly portion). Photo: Eduardo Q. de Lima.
